## System findings and recommendations

**Site:-**  
**System:- Grill Bar System**

**Date of survey :- 06.10.15**  
**Carried out by: Maurice Lavery**

## MONITORING REPORT AT

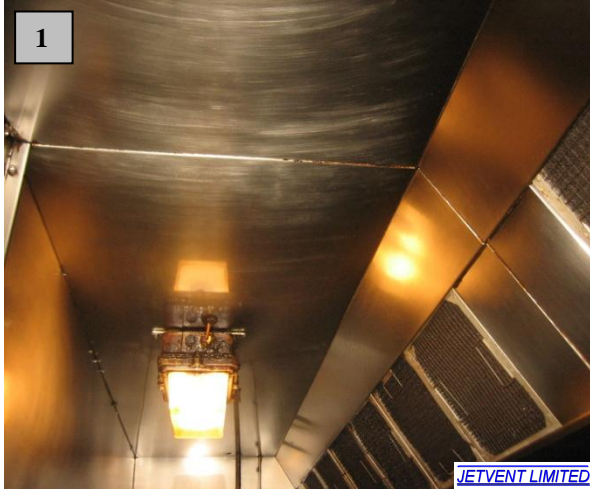
Locations Area	At Survey	COMMENTS
Canopy	1	Reasonable condition
Filters	2	Clean required
Canopy risers	3 + 4	<b>High risk clean required</b>
Ductwork above canopy/plenum	5	<b>High risk clean required</b>
Ductwork upstream to fan	6 + 7	<b>High risk clean required</b>
Fan	8	Clean required
Discharge hood		
Any Leakage outside the duct		Ceiling tiles showing signs

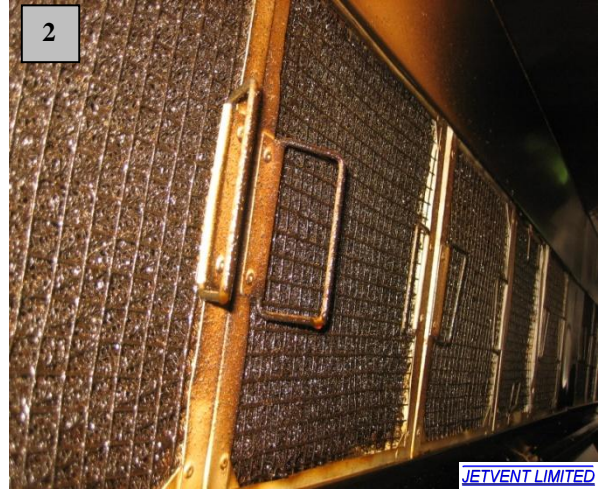
Engineers Notes: **This system has a very heavy contamination present well above industrial standards. There has been no cleaning carried out within the ductwork for years. (Please see photos). Recommend system ducting to have immediate cleaning carried out. Filters are dripping grease. A very high risk is present above cooking stations.**

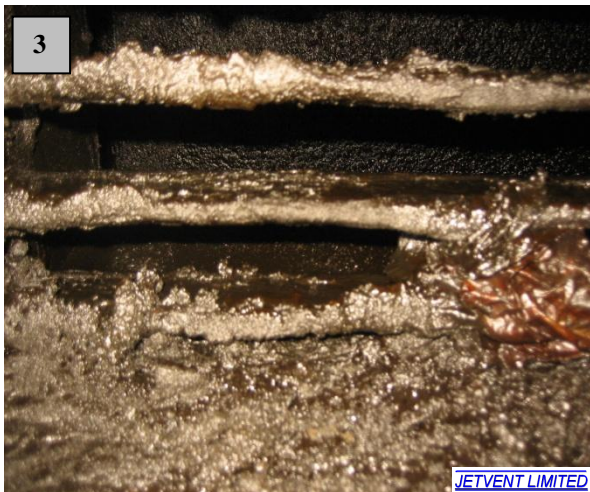
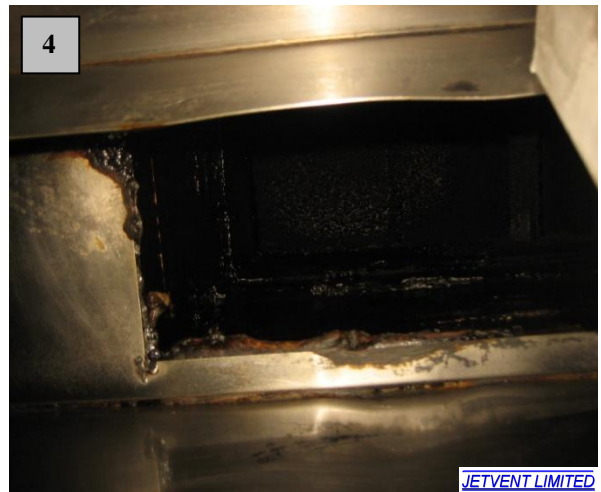
Locations: Describe Area	<u>WFTTM</u> Before	Very Dirty	Dirty	Slightly Dirty	Clean	<u>COMMENTS</u>
Canopy/housing	<b>1500</b>				✓	
Canopy riser (x2)	<b>10000+</b>	✓				<b>High risk</b>
Ductwork at plenum above canopy	<b>13000+</b>	✓				<b>High risk</b>
Ductwork upstream to Fan	<b>5000+</b>	✓				<b>High risk</b>
Fan/ housing	<b>2000</b>	✓				
Fan hood	<b>1000</b>	✓				
<b>TOTAL WFTTM</b>	<b>32500</b>					
<b>MEAN WFTTM</b>	<b>5417</b>
